My Story So Far - Pt III By SMM 34643

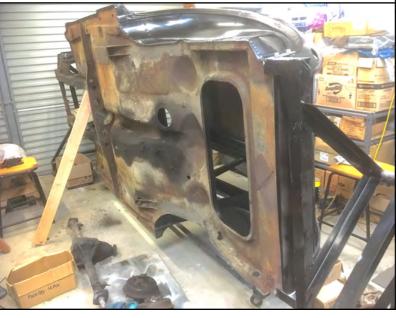
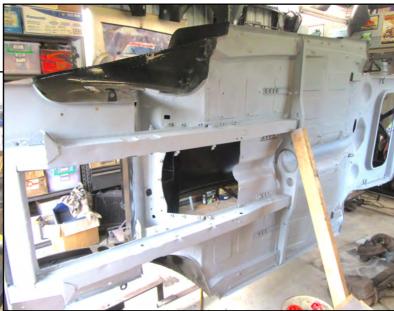
(left) Ready to attack the underside and (above) successfully attacked and beaten into submission

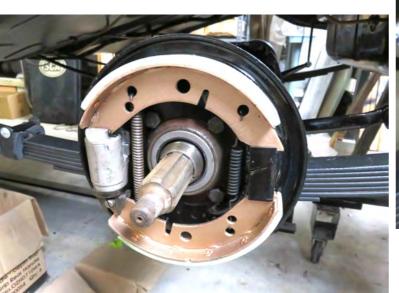
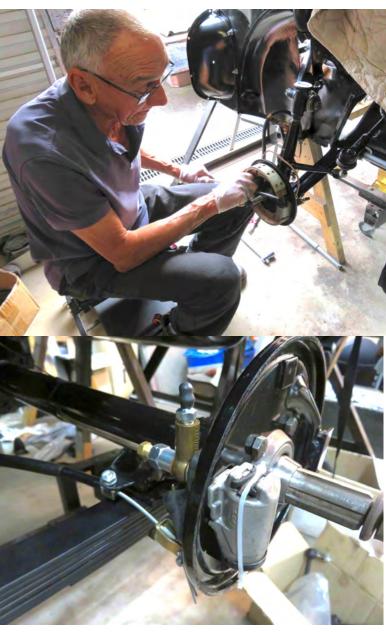
Johnny B working on my brakes (right) and the finished products. Now I'll be able to go - and stop! :)))

Les had already fitted my rear brake cylinders, shoes and drums, and no sooner

had Johnny B arrived than he was into it, finishing off my front brakes. Before long my front and rear brake drums had been installed and I was ready to be shod with wheels. Yippee!

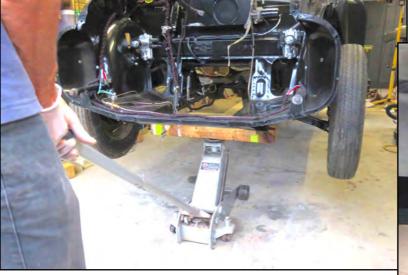
With the brakes all done, Johnny B lowers me down gently

That same afternoon, with wheels bolted on, they began the delicate operation of jacking me up - first removing the horse supporting my front, and then the rotisserie section holding up my rear end, each in turn. I'm glad to say it went smoothly, and there I was - back on terra firma; well, back on the concrete floor of the shed, anyway.

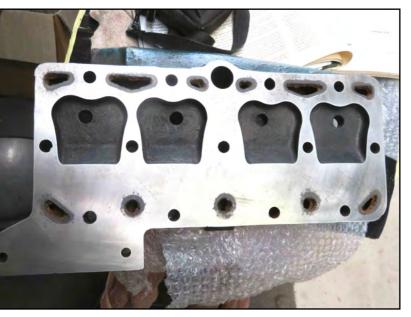
My shiny Allan Hall-skimmed head...

With all of my valves in place, it was 'Head Time'! This had already been skimmed by Allan Hall, after which Les had given it a nice coat of the green paint, so it was all prepared to go back on.

With a shiny new gasket placed over the studs, the head slid on nicely, and after the distributor was inserted into its correct position, Les torqued down the nuts in sequence. Fantastic progress!

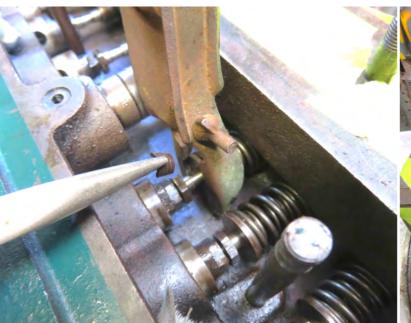
Line 'em up! All ready for assembly

Top on the agenda for Les' next trip down was Engine Reassembly. First, to install the double valve springs, valves caps and collets, and then to get my head back on, which I thought had been off for far too long already! Les took a couple of hours to work out the best approach and finish the first two valves, and less than 2 hours to do the next six! He used Johnny B's spring compressor to get the cap in place, then the standard one to get the collets in. He was learning!

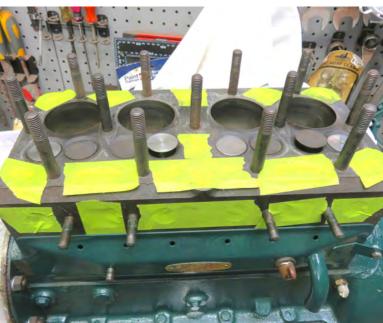
Surgical procedure with the collets matches hospital scale cleanliness

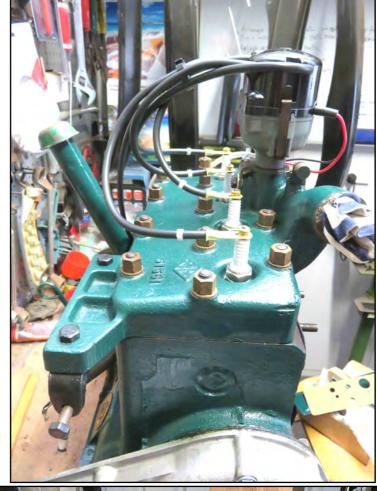
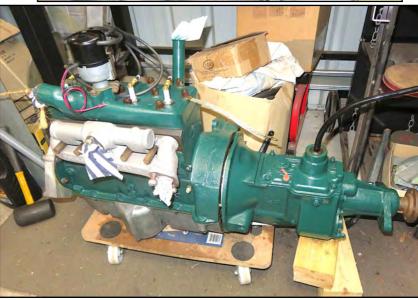
The final engine piece for the moment was to fit the clutch. Les checked the lockwiring of the 4 bolts that he had done some time before, then fitted up the clutch using an old gearbox shaft to line up the splines with the spigot bearing.
